Arona AD182M Engine Information

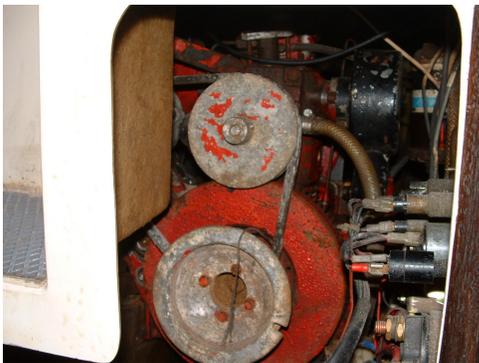
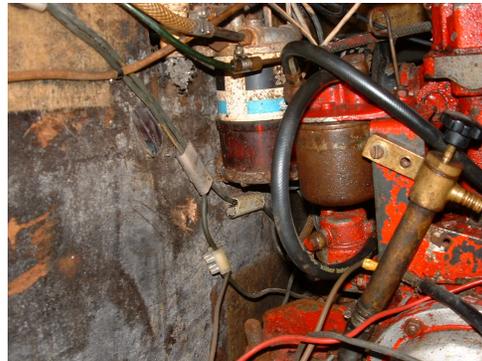
The engine was in a filthy and corroded state in the boat, as seen in these pictures.

I find it amazing that someone could let their engine and gearbox get in such a mess, who would want to do even routine servicing on it as you're going to get filthy just checking the oil !

I therefore removed the engine from the boat completely, together with the gearbox as seen in this picture. The gearbox was a standard Hurth marine gearbox and was relatively easy to get parts for and mend although the manual at £25 which consisted of a few pages photocopied and plastic ring bound together seemed very expensive!

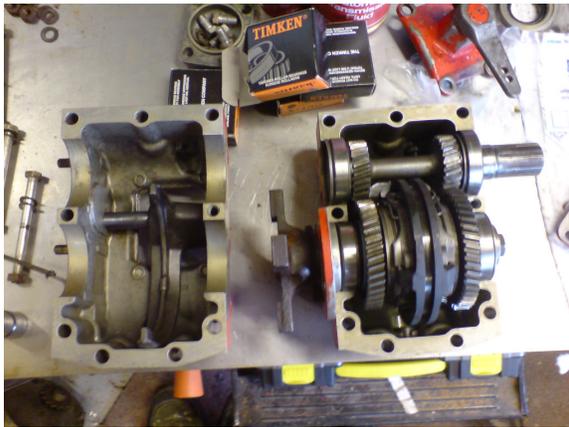
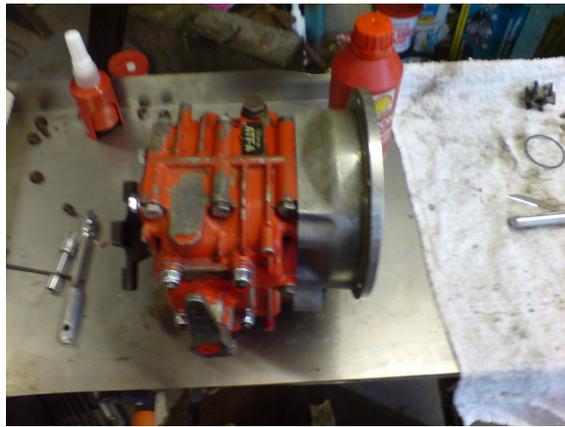
The pictures below are of the gearbox in pieces and then reassembled, as I said its very easy to work on so don't be put off if you think yours needs

attention.
